Analysis of Road Surfacing Using the Pavement Condition Index (PCI) and Surface Distress Index (SDI)

Dio Vikram, Erizal, and Apriadi*

Department of Civil and Environmental Engineering, IPB University, Bogor, 16680, Indonesia
*Correspondences: apriadi@apps.ipb.ac.id

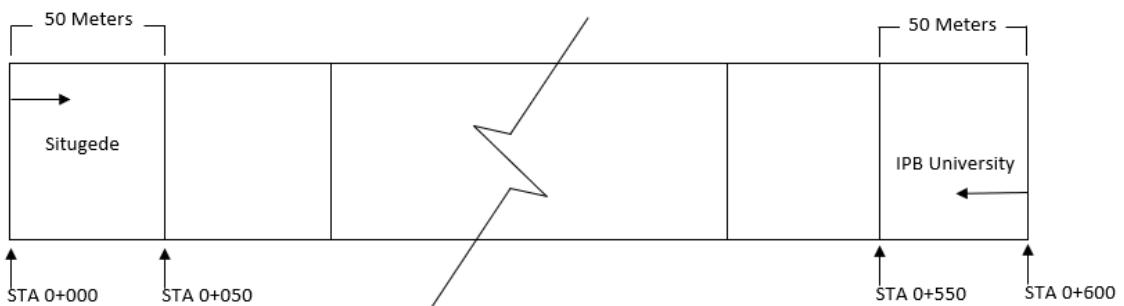
Figure 2. Road are devide into segment

site is asphalt, thus falling under the flexible pavement category. The research location is divided into 12 segments, each 50 meters long, as shown in **Figure 2**. This follows the reference requirement for each segment to be (225 ± 90) m² in area. The SDI method refers to SMD-03/RCS [15] on Road Condition Survey Guidelines. The SDI method assesses the condition of asphalt roads per kilometer of road.

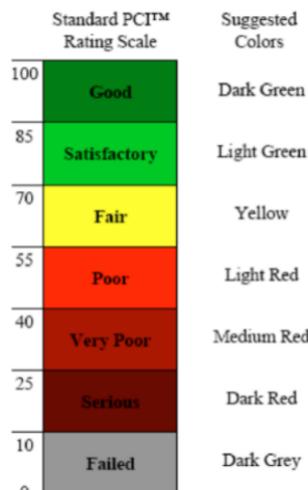
Figure 3. PCI Rating Scale [13]

Next, the corrected deduct value for each segment is calculated using an iterative technique. Deducted values greater than 2 are totaled. The corrected deduct value is determined from the total corrected deduct value of individual deduct values greater than 2, then linked to the q value using the CDV curve. Iteratively, deduct values greater than 2 are adjusted to 2. This adjustment is repeated until $q = 1$. The largest CDV value in a single iteration cycle is used to determine the PCI value using equation (4), and the PCI values are averaged using equation (5). The obtained PCI values are identified based on the PCI value rankings in **Figure 3**.
